TECHNICAL SERVICE BULLETIN

TSB-OT-0019 REV2

Subject: Revision - 5-Ton Rooftops DFG/DFC Missing Valve Cores in Pressure Switches

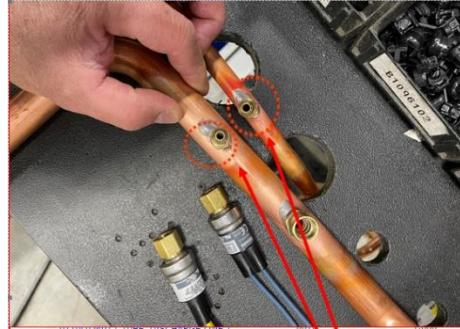
Image 1
Valve Core Omitted

It has come to our attention that the new 1- and 3-phase, 5-ton gas/electric and air conditioner rooftop units (RTU), models DFG and DFC, are missing the valve cores in the low-pressure and high-pressure switch assemblies (see Image 1 below).

All 5-ton (DFG/C060*) RTUs, with serial numbers up to 2202235971, should not be sold or installed until the rework is completed. It is strongly recommended that all distributors promptly contact and inform any customers that have purchased and/or installed any of these units of the required rework by way of this bulletin.

A valve core or tee must be installed per the instructions below using kit CPSKT01. Failure to follow these instructions could result in injury and complete loss of charge.
