## TECHNICAL SERVICE BULLETIN

**TSB-OT-0005**

**Date:** October 27, 2020  
**To:** Internal, Sales, Distribution, Sales and Service Representatives  
**From:** Stuart Werner, Vice President, Technical Services  
**Subject:** Missing Gasket - DBG 7.5- to 10-Ton Packaged Rooftop Product

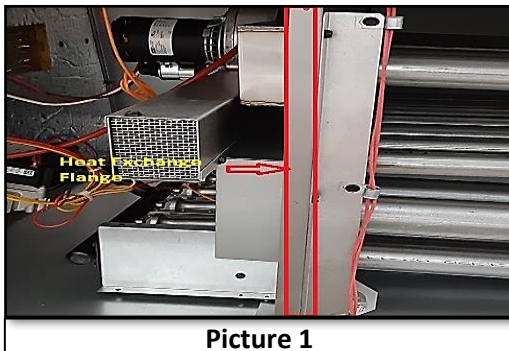
**Picture 1**

Daikin North America LLC has recently identified an issue with DBG 7.5- to 10-ton packaged rooftop units. A gasket separating the supply side from the combustion chamber was missing from the heat exchanger flange, as shown below in Picture 1. The purpose of the gasket is to prevent supply air from entering the combustion chamber and affecting heating operation as shown in Picture 2. This issue has now been corrected in production.

Daikin regrets any inconvenience that this may have caused to our customers. For customers with affected models, a kit has been created (**Part Number: CSSKT01**) and can be ordered through service parts.
