# TECHNICAL SERVICE BULLETIN

## TSB-C-GN-SP-0032

**Date:** July 11, 2023  
**To:** All Service and Parts Managers  
**From:** Technical Services Department  
**Subject:** Air Handler (ACNF) Motors Rotating the Wrong Direction

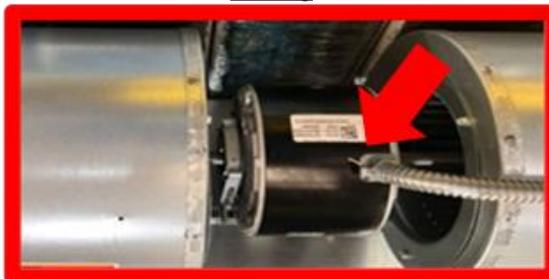
We have received field reports of ACNF air handler motors rotating the wrong direction. We have determined that the motors were installed in the wrong orientation during production. The affected **serial number range is 2301717602 to 2305728689**. The model revisions listed below are the affected units. Distributors with affected ACNF units in the serial number range above should quarantine units for rework on site or return to DTTP to rework by requesting a Logistics RMA. Units installed in the field will need the motor removed and re-installed in the proper orientation. The instructions below should be used to rework the units.

**Wrong**

### Instructions for removing and re-installing the blower motor on ACNF:

1. Turn power off to indoor unit.
2. Loosen set screw on each blower wheel, making sure wheel will spin freely.
3. Remove the venturi rings on the outside of the blowers and remove blower wheels.
4. Remove the ground wire from the blower housing.

5. Remove the blower assembly on the right side.
6. Loosen and remove bolts holding motor, rotate motor 180 degrees and reinstall motor.
7. Re-install the blower assembly and use caution when tightening the screws to keep from overtightening. Use the next size larger screw if needed.
8. Reattach ground wire to blower housing making sure not to overtighten screw.
9. Re-install blower wheels and check to ensure the blower wheels are centered in the blower housing and spin freely without touching the housing.
10. Ensure the blower wheel set screw is properly tightened without stripping set screw.
11. Install venturi rings making sure not to overtighten screws.
12. Turn on power to indoor unit and check for proper motor rotation.

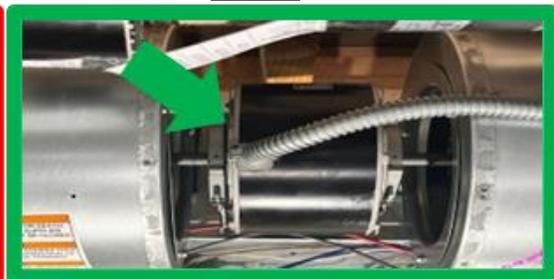
**Correct**
