TECHNICAL SERVICE BULLETIN

TSB D-LC-0039

Date: October 6, 2023
To: Internal, Sales, Distribution, and Sales Representatives
From: Technical Service Department
Subject: Inspection and Repair of DFC/DFG Condensate Drain Pan Supports

Model Groups Affected	
DFG090-102	DFC090-102

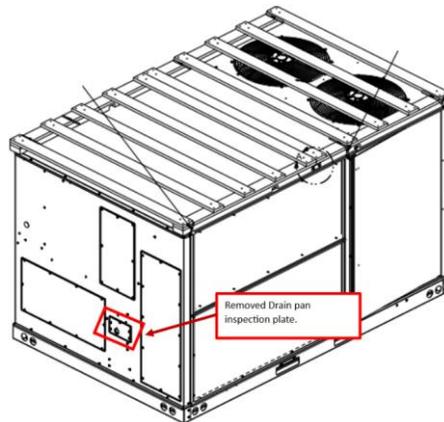
1. Disconnect the condensate drain trap.
2. Remove the drain pan inspection plate shown in Figure 1 below.

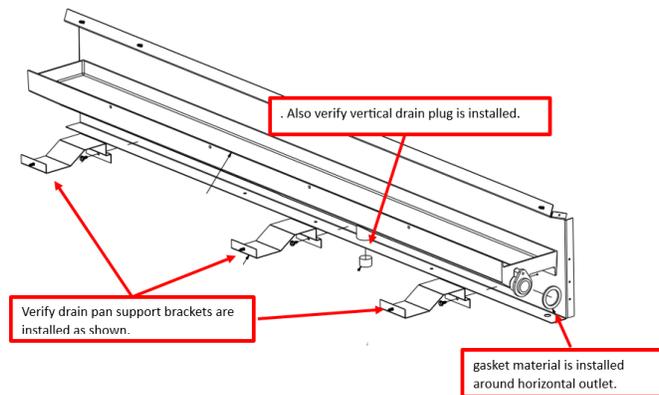
1. Remove the drain pan.
2. Inspect the drain pan for vertical drain plug and gasket or any other possible defects.
3. Inspect the support brackets.

Note: See Figure 2 below for assembly details.

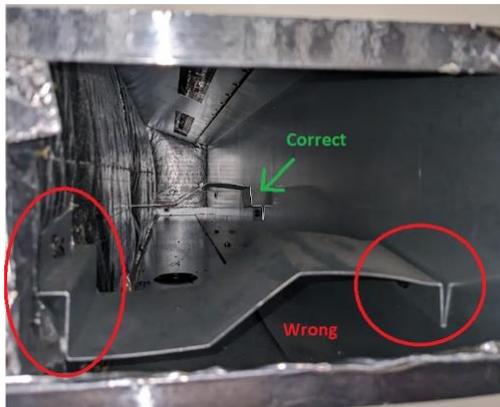
It has come to our attention that some 7.5- and 8.5-ton air conditioners (DFC) and gas/electric (DFG) packaged rooftop units produced prior to serial number 2308224444 may have been produced with the drain pan support brackets installed incorrectly.

Example of incorrect install:

Note: If the support brackets are found to be incorrect, as shown in the image above proceed to the "Repair Process" below.

3. Reinstall the middle bracket #2 in the correct orientation.
4. Reinstall the front bracket #1 in the correct orientation.
5. Reinstall the drain pan.
6. Reinstall the drain pan cover.
7. Reconnect condensate trap.

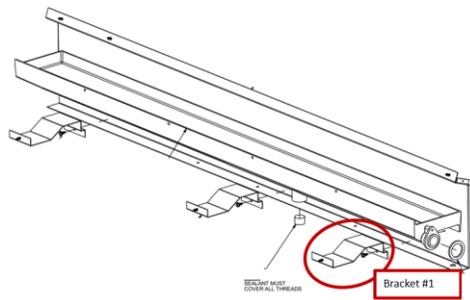
- Right angle drill attachment or equivalent (see image to the right)
 - Drill
 - Drill Extensions as needed.
 - 5/16" hex driver
1. Remove the front bracket #1 and set aside.
 - a. You will need this bracket in step number #4.

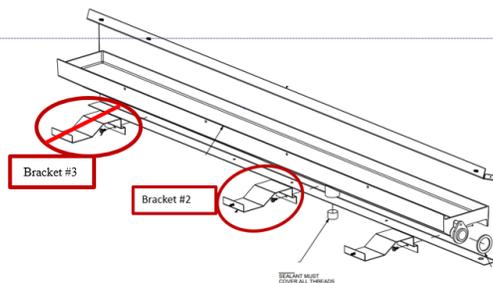
2. Remove the middle bracket #2.

Note: Bracket #3 does not need to be removed regardless of orientation.
