TECHNICAL SERVICE BULLETIN

TSB D-LC-0035

Date: Date, 2023
To: Internal, Sales, Distribution, and Sales Representatives
From: Technical Service Department
Subject: **Commercial Split System (DAX) Transformer Possible Incorrect Wiring**

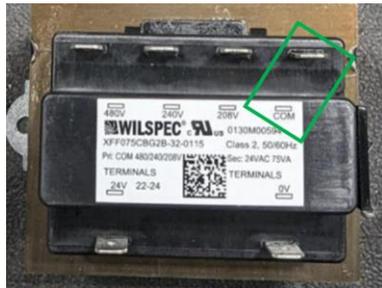
We are providing this notification that there is the possibility when the Wilspec transformer was used in the production of the commercial split system DAX090 and DAX120 models, it could have been wired incorrectly. If so, this could cause low secondary voltage resulting in chattering contactors or contactors not closing.

If you are experiencing low secondary voltage on units manufactured **prior to serial number 2308370481**, check the connection points on the line side of the transformer to ensure that the "black" lead is on the common terminal, and the "Orange" lead is on the desired incoming line voltage terminal. See image of transformers below for COM terminal locations.

Verify Transformers are terminated correctly.
